2020 Wetland Report

Iron Horse Park Superfund Site: AOC 3

Billerica, Massachusetts

30 December 2020

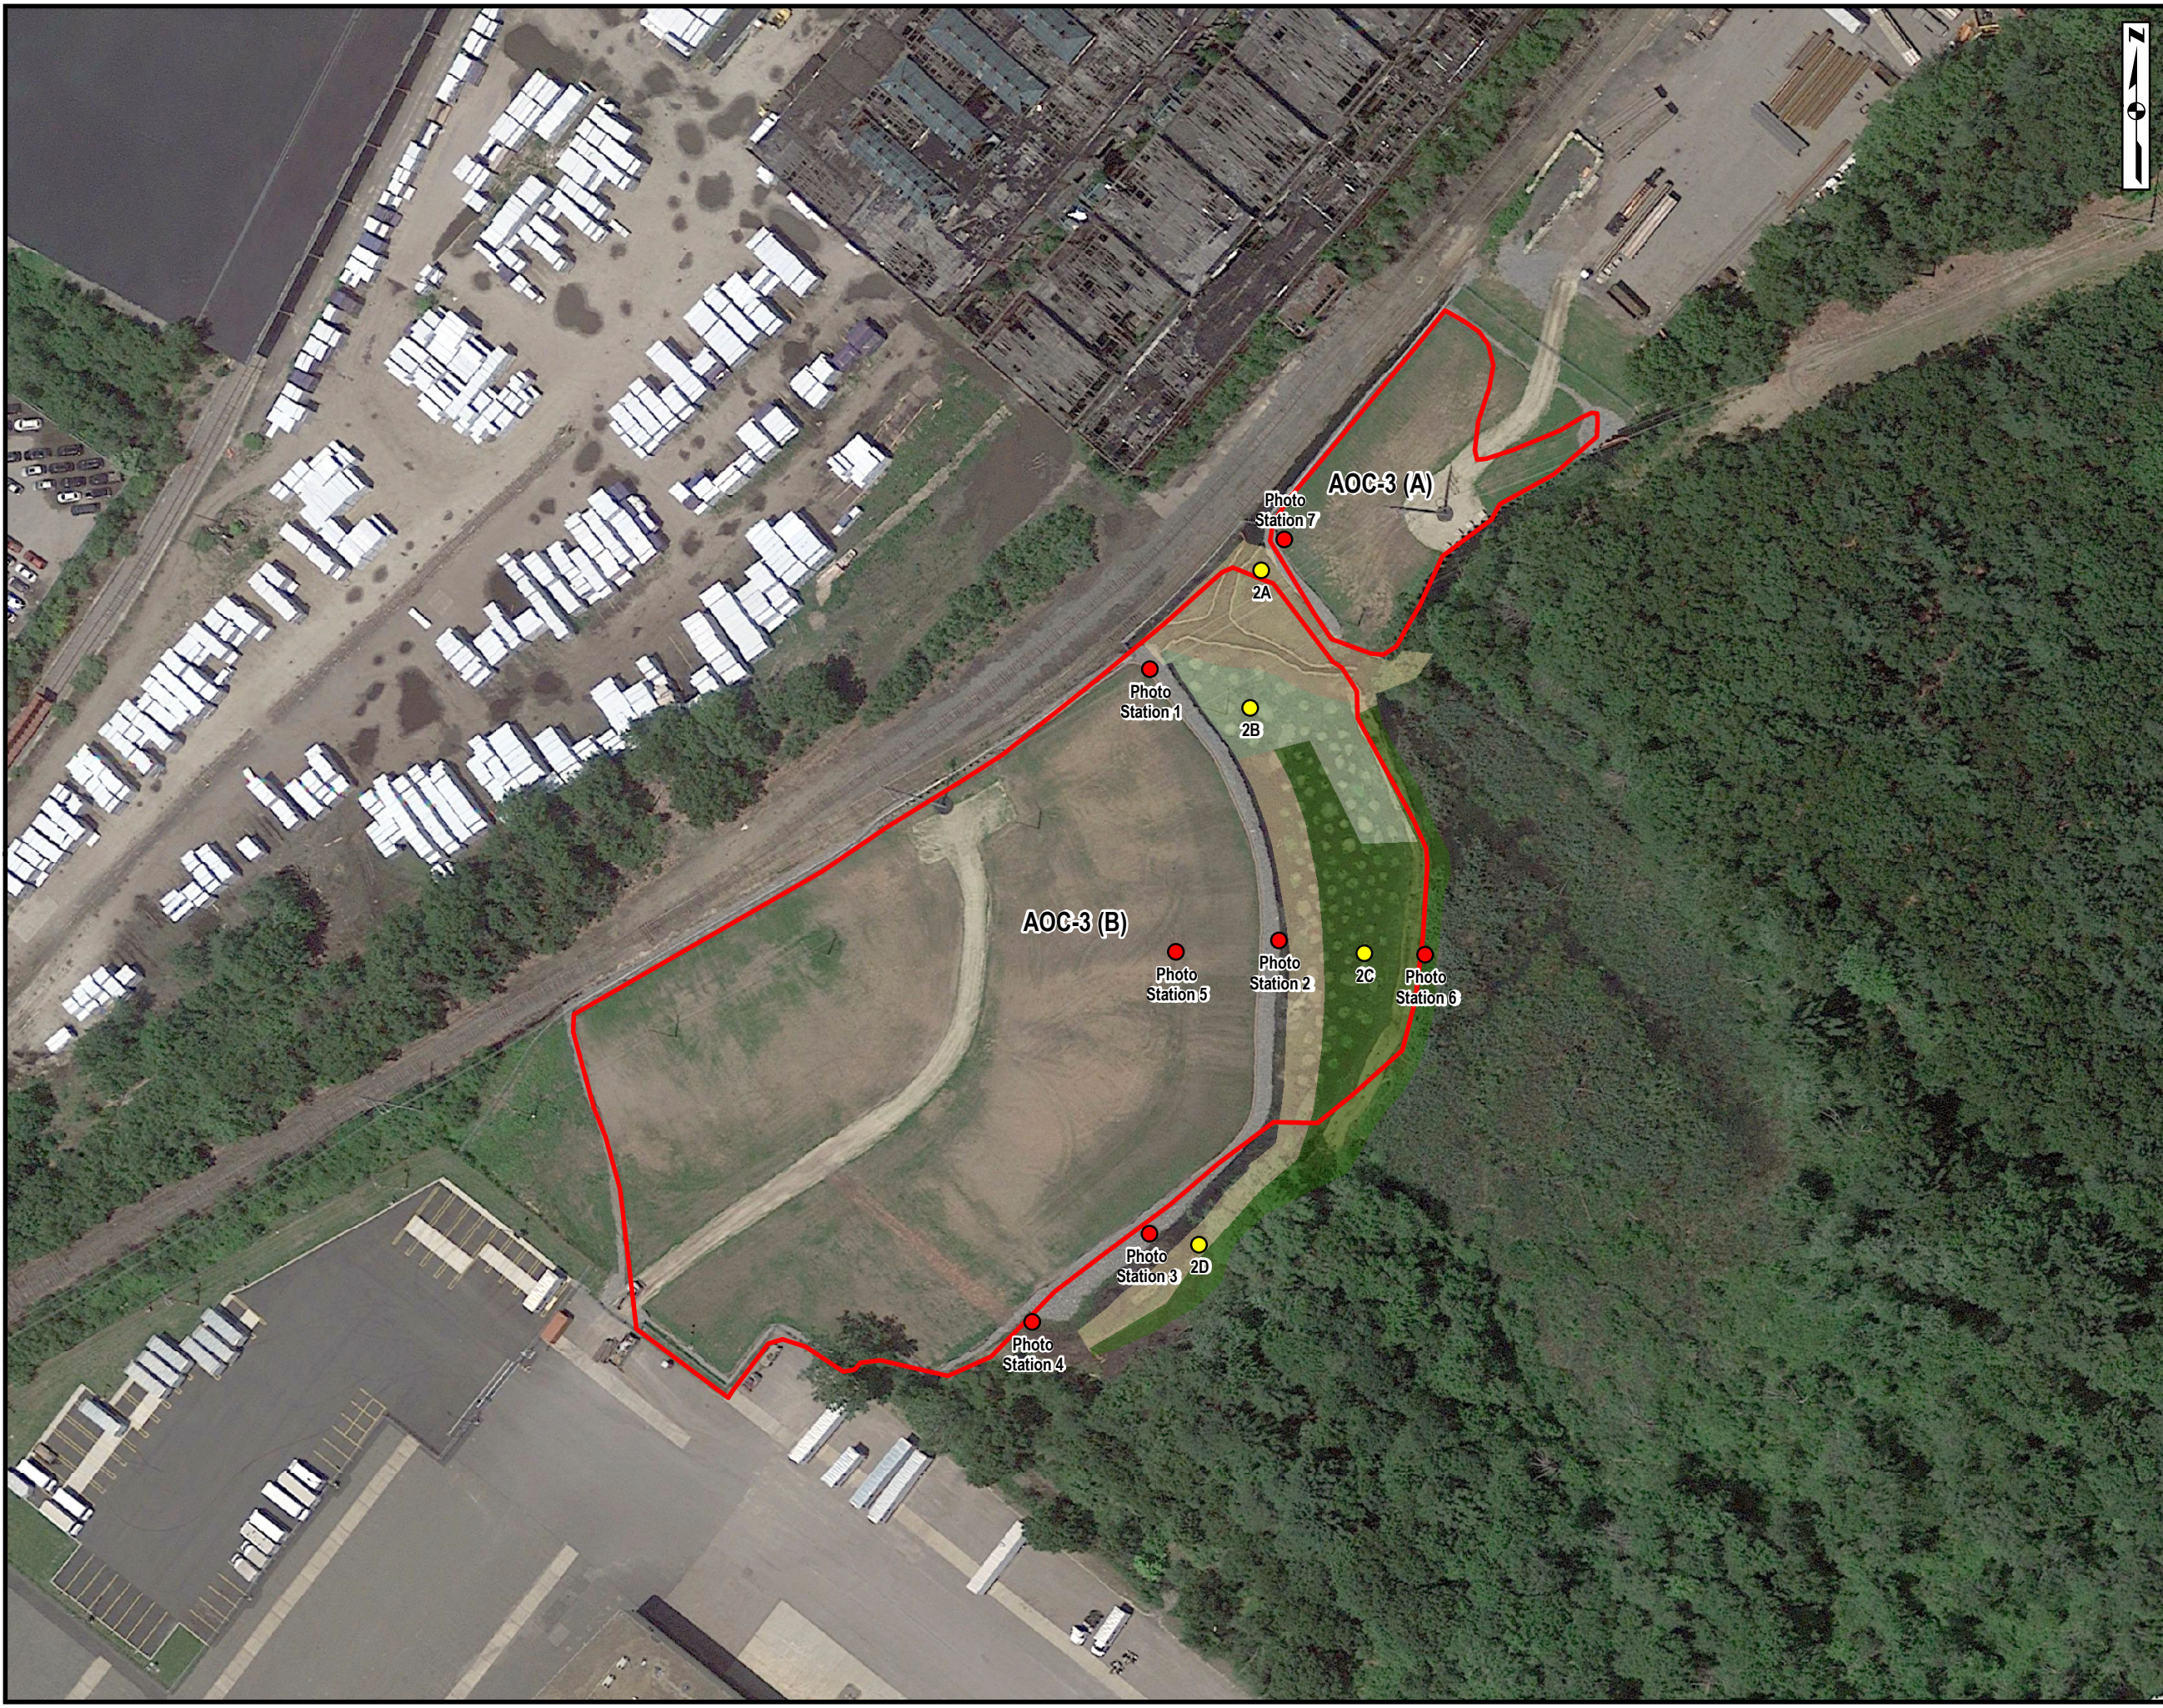
Figure 2 - Wetland Monitoring
 Iron Horse Park Superfund Site
 Billerica, Massachusetts
 October 2019

- Legend**
- Photo Stations
 - Long Term Wetland Sample Plots
 - Palustrine Forested Wetland (PFO)
 - Palustrine Emergent Wetland (PEM)
 - Palustrine Scrub Shrub (PSS)
 - AOC-3 Boundary
